CORROSION-RESISTANCE OF REINFORCING BARS: An Accelerated Test

Epoxy-coated bars have shown good corrosion protection in concrete structures since 1973. Recently, interest in other corrosion-resistant bar systems has resulted in new products being supplied to the marketplace. Tests were conducted by Wiss, Janney, Elstner Associates using a wide range of products including 15-year old epoxy-coated reinforcing bars that had been removed from salt-contaminated concrete. Results from the tests show that even old coated bars perform significantly better than other products. This work supports conclusions of other longer-term research, that epoxy-coated bars provide cost-effective corrosion protection.

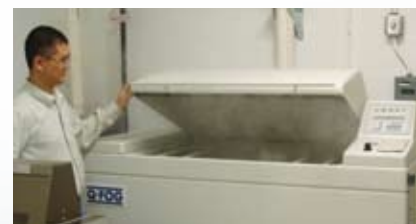
The testing is conducted in a closed chamber, where a salted solution is sprayed by means of a nozzle. This produces a corrosive environment in the chamber and thus, parts in it are attacked under this severe corroding atmosphere.

Reinforcing bar samples were tested in a fog cabinet for a period of 28 days. During this period they were exposed to a 5% sodium chloride fog at 35°C following the ASTM B117 protocol.
